ISO ZONE D – UNACCEPTABLE · 1 COMMITTED FINDING

Synthetic Compressor 01 · compressor

Bearing outer-race fault (BPFO)

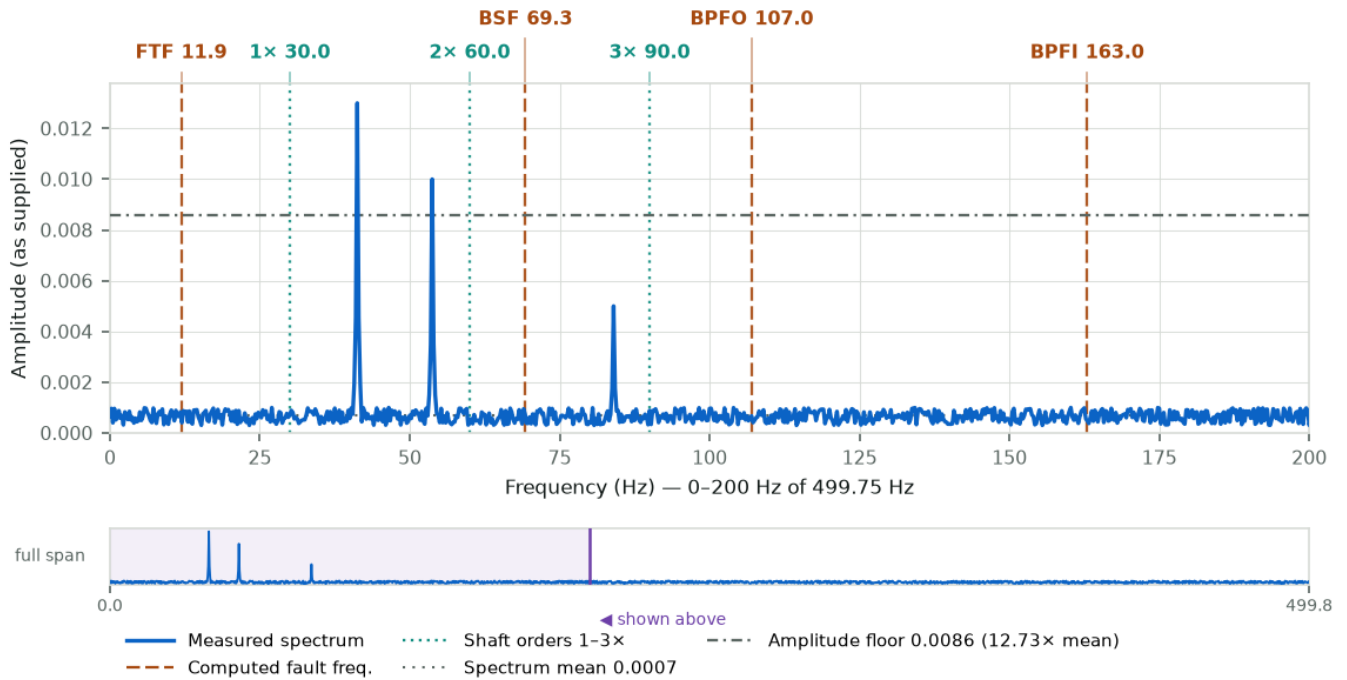
Envelope spectrum, X axis. No peak on this channel matched a computed fault frequency within tolerance.

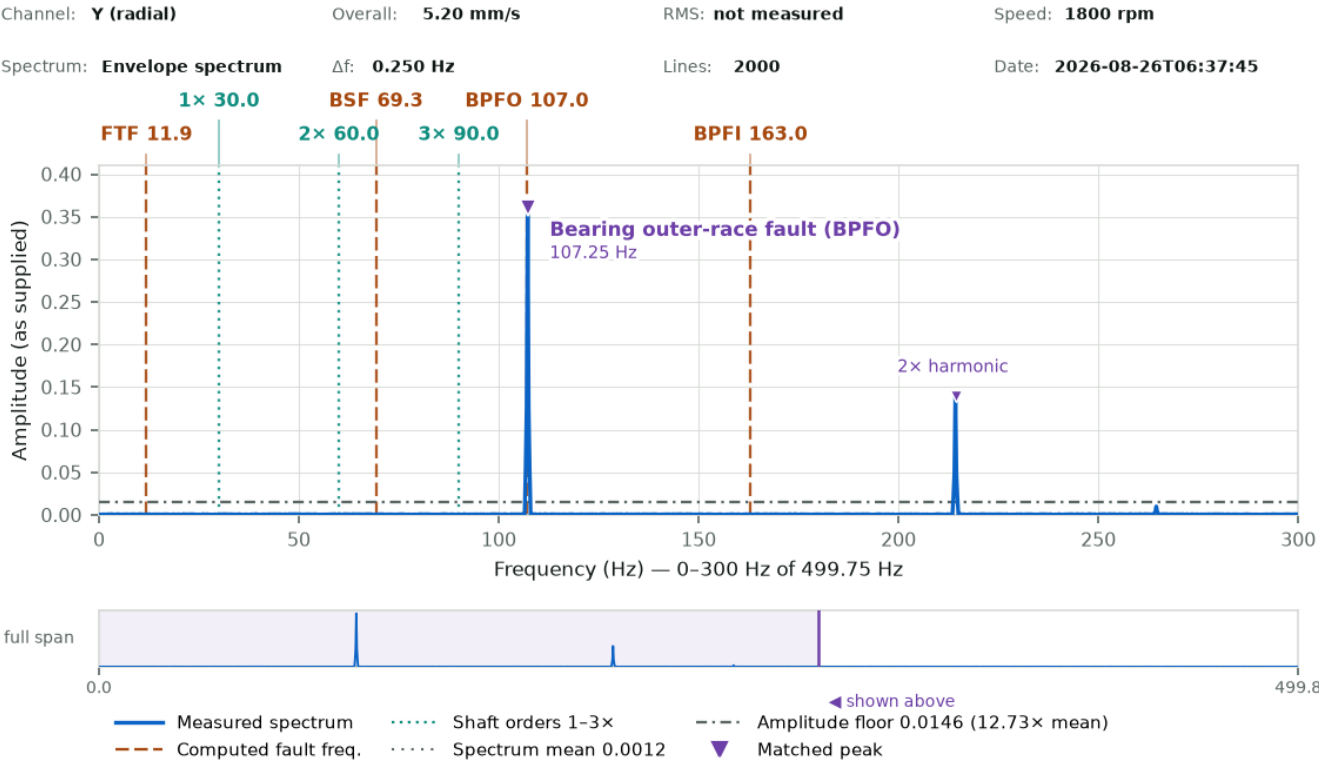
Envelope spectrum — Y (radial)

The rank-1 peak on the y-axis at **107.25 Hz** matches the computed BPFO of **107.03 Hz** for the 6206 bearing at 1800 rpm, a deviation of just 0.20% — well within the  $\pm 3\%$  match tolerance. The amplitude of this peak (0.36, rank 1 on the y-axis) is the dominant spectral feature on that axis. A **2× BPFO harmonic at 214.25 Hz** (rank 2, amplitude 0.14) is also present, providing independent corroborating evidence of the outer-race defect frequency. The y-axis is the expected radial axis for this bearing configuration, and the fault tone appearing there is consistent with the expected directional pattern for a BPFO excitation.

Envelope spectrum, Y axis. Matched: bearing outer race at 107.2 Hz.

- 1. **Plan bearing replacement** at the next available maintenance window. The machine is operating in the danger band with a confirmed outer-race defect frequency and harmonic; continued operation without intervention carries an elevated risk of accelerated damage progression.
- 2. **Monitor closely until replacement.** Given the severity level, increase monitoring frequency on this asset. Any further rise in overall vibration level or the appearance of additional harmonics or sidebands should be treated as a trigger for expedited intervention.

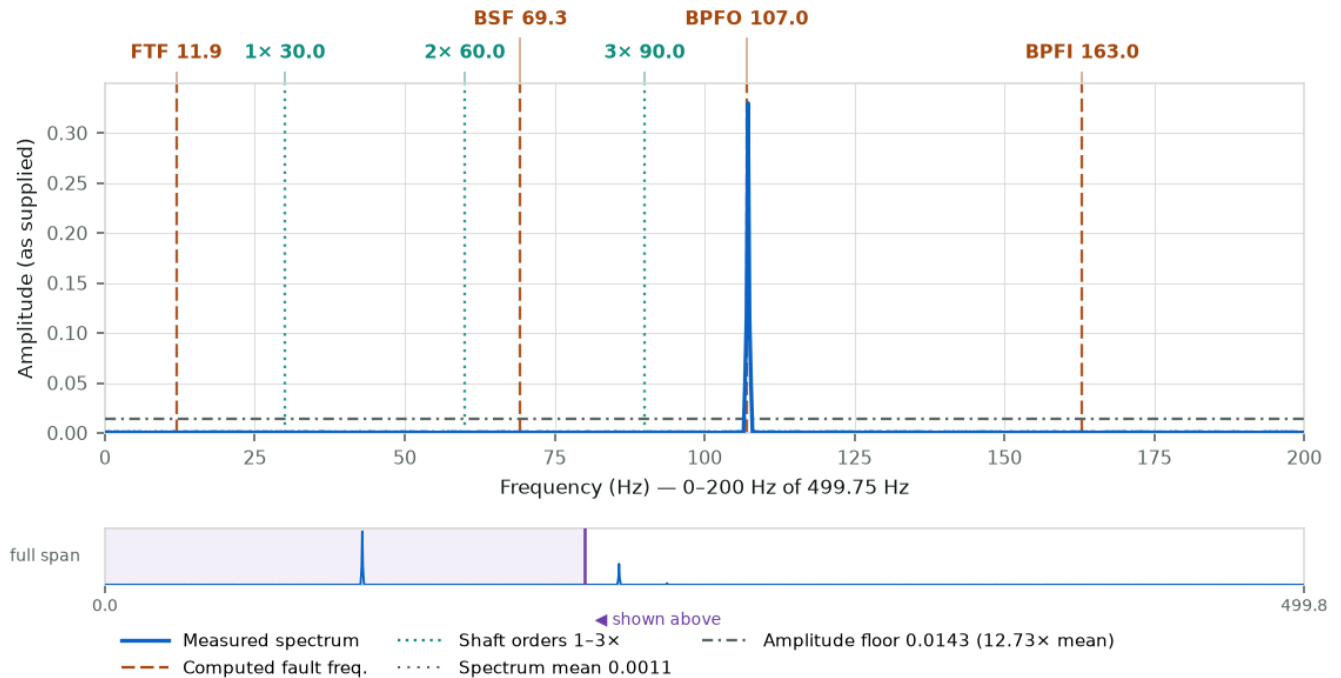
## Envelope spectrum — Z (radial)

Envelope spectrum, Z axis. No peak on this channel matched a computed fault frequency within tolerance.
