ISO ZONE D – UNACCEPTABLE · 1 COMMITTED FINDING

Synthetic Compressor 01 · compressor

Bearing outer-race fault (BPFO)

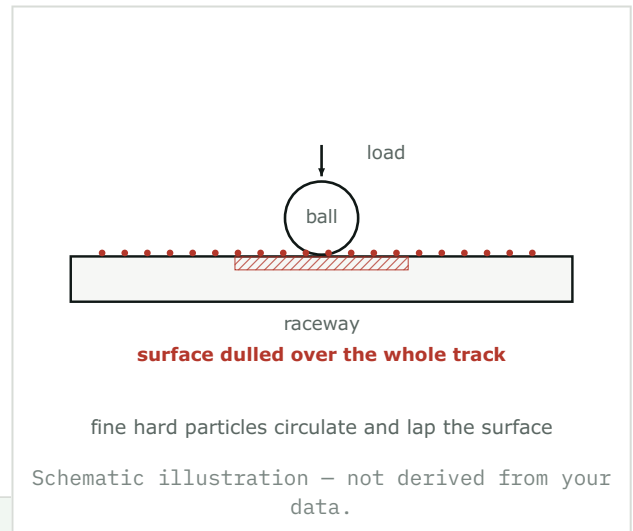
- Broadband rise across the spectrum without a clean BPFO series, since distributed roughening is not a single repeating impact.

- A matt, dullled or lapped-in raceway track rather than a discrete pit, with parallel furrows in the direction of motion where the particles are coarser than the lubricant film. How to collect: Dismounted inspection of the raceway under low magnification, in raking light.
- Wear spread around the circumference of the stationary ring rather than concentrated in one arc. Weak on its own, and arguably contradicted by our own source - #01 p.67 shows a STATIONARY inner ring carrying two localised wear zones - so distribution does not separate contamination from creep. How to collect: Map the wear extent against the recorded ring orientation before cleaning.

- Rising ferrous particle counts and cutting/abrasive particle morphology in the lubricant before any discrete defect tone appears. How to collect: Oil sample from the return line or reservoir mid-level, with particle count and analytical ferrography.

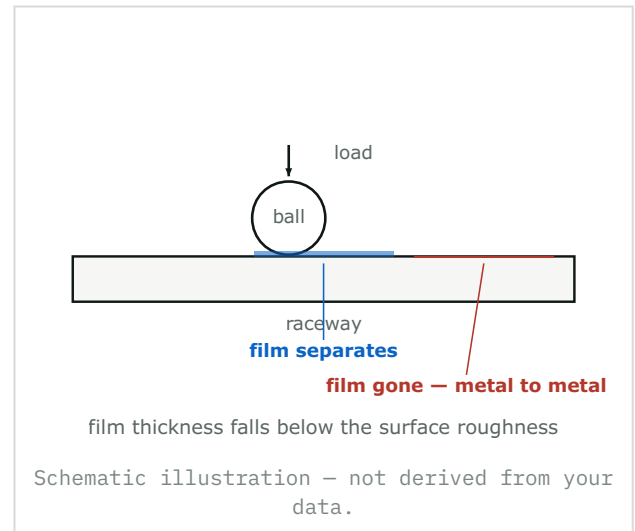
- Bearing temperature climbing and failing to settle at a steady state in stationary operation. #03 reports temperature as the reliable indicator of a lubricant-supply fault and, in its own stopped-lubrication test, the shock value as the less sensitive of the two; that is a claim about that comparison, not a general ranking of thermal over vibration. How to collect: Thermocouple at the bearing housing, trended over a run-up to steady state rather than spot-read.

- Dull, lustreless or frosted raceway over a broad area rather than a discrete pit, sometimes with heat discolouration. How to collect: Dismounted inspection; note discolouration separately from wear.

- Abraded matter measurable in the lubricant, which #03 lists as a lab route to bearing condition alongside temperature and vibration. How to collect: Oil sample sent for wear-debris measurement, kept as a trend rather than a single reading.

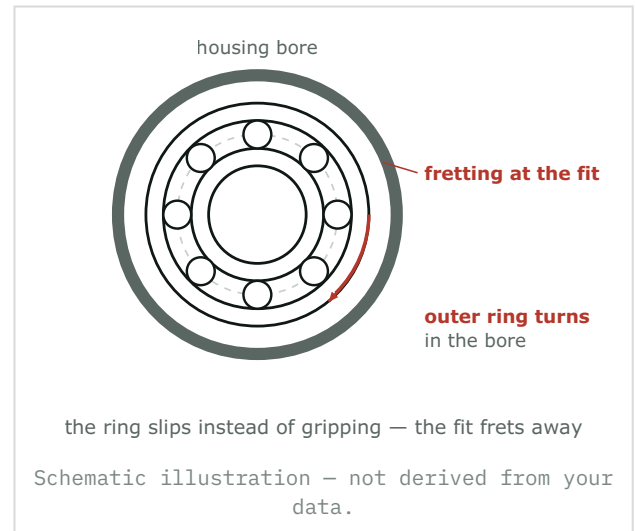
### 03 Housing fit inadequate for the load condition, letting the outer ring creep

An outer ring that is not held firmly enough for the direction and rotation of the load turns slowly in its housing instead of staying put. The relative movement polishes and wears the outside surface and shifts the load zone, so the raceway damage no longer sits where the applied load says it should.

- Rising broadband noise and vibration level with no matching change in the fault-frequency evidence. #01 gives raised noise and vibration as a consequence of ring creep, so this is a corroborating level symptom, not a frequency signature.

- Polishing wear, or adhesive wear marks, on the ring outside diameter - damage outside the rolling contact entirely. The appearance is not fixed to one wear mode, so an unmarked OD is the negative finding, not a particular finish. How to collect: Inspect the ring OD at dismounting, before cleaning it.

- A load-zone mark that has migrated, or two wear zones on one OUTER ring, rather than a single arc consistent with the applied load direction. #01 documents that two-zone pattern for a creeping INNER ring; the outer-ring analogue is ours. How to collect: Record the ring orientation relative to the load before removal, then map the wear arc against it.

- A rotating outer ring load, or a history of shaft unbalance. #01 names unbalance as a cause of outer-ring creep even where the fits were originally correct, which gives this cause a machine-side antecedent the vibration path can detect on its own. How to collect: Balance records and 1x amplitude history for the machine, alongside the seat measurements.  
[#01 §2 Inspection and troubleshooting, Table 2 solution code 31, p.24]

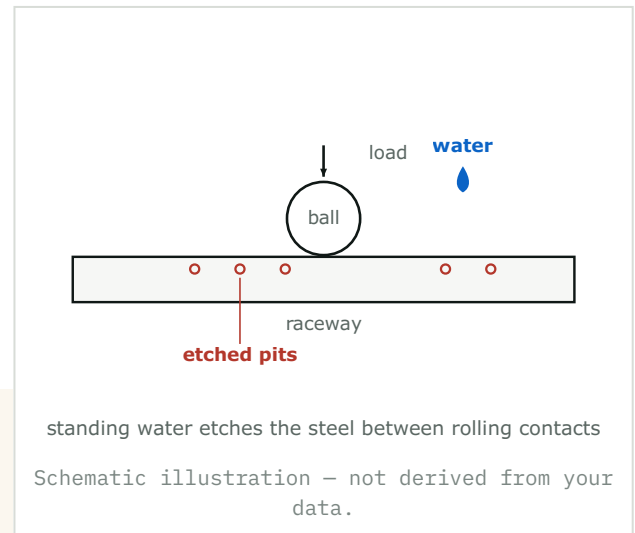
Water in the bearing attacks the finished steel surface chemically, with no metal-to-metal contact required, and etches or pits it. The pits then act as stress raisers under rolling contact, so a corrosion problem presents later as a fatigue one. [#02

COLOUR IS NOT A DISCRIMINATOR HERE. #04 p.8 assigns the reddish-brown oxide colour to FRETTING corrosion - rust without water being present - which is this entry's nearest differential.

- Staining or pitting on the raceway, in an even and uniform pattern where standing water did the work, and confined to the LOWER portion of the component where water was left undrained in the sump. How to collect: Dismounted inspection with the component's installed orientation recorded, since the localisation is the discriminator.  
[#04 Corrosion, p.7] [#02 Etching - Corrosion, p.9, figs. 12 and 16]

- Whether the staining polishes out. This is a disposition boundary, not just a description - staining that cleans up with fine emery or crocus cloth permits reuse, pits that will not clean up condemn the bearing. How to collect: Light polish of a stained area with fine emery or crocus cloth, then re-inspect for surviving pits.  
[#02 Etching - Corrosion, p.9, fig. 12]

- Free or standing water in the lubricant, including water left undrained in the sump. How to collect: Oil sample and a sump low-point drain check, taken before the system is topped up or flushed.  
[#04 Corrosion, p.7] [#02 Etching - Corrosion, p.9]

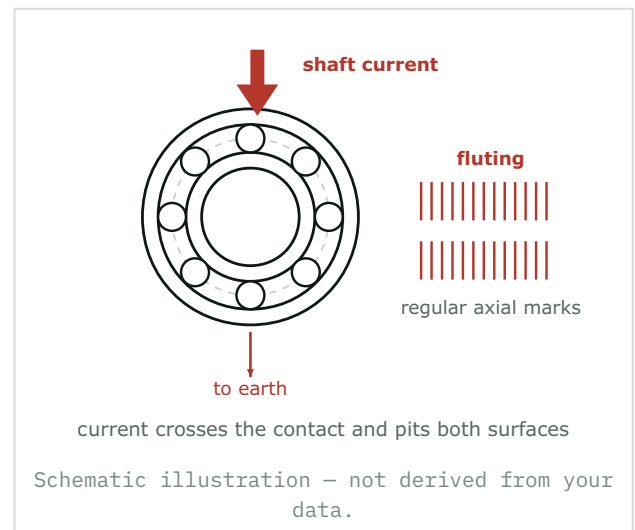
## 05 Stray shaft current passing through the bearing to earth

Current crossing the lubricant film discharges through the contact and melts microscopic craters in the raceway. Continuous low-level leakage produces closely spaced craters that develop into axial fluting, while a high-energy discharge produces isolated deep pits. [#01 §4 ISO failure modes classification, Electrical erosion, pp.53-54] [#01 §5 Damage and actions, Excessive current erosion and Current leakage erosion, pp.74-76] [#04 Electrical Erosion, pp.9-10] [#02 Burns from Electric Current, p.21] [#43 Table 4-5 Cause of Motor Bearing Failure, p.4-15 (PDF page 45)]

- Regular fluting running parallel to the rolling axis, presenting as a staged progression - a dull grey zone with small shallow craters, then early fluting, then advanced fluting. How to collect: Dismounted inspection of the raceway across its width, in raking light.
- Flute PITCH, not the presence of flutes. Fluting is not electrically exclusive - #01's own glossary gives washboarding as mechanical periodic transverse wear associated with abrasive wear in lightly loaded bearings, used interchangeably with fluting but usually more widely spaced. How to collect: Measure the mark pitch across the raceway rather than recording only that periodic marks are present.

- Craters massed in a bead-like or zig-zag formation rather than distributed as a flute, which #01 attributes to excessive current as distinct from continuous leakage. How to collect: Inspect rollers and raceway under magnification and record the crater pattern, not just its presence.  
[#01 §5 Damage and actions, Excessive current erosion, p.74]

- Arc pitting or small burns where the machine was STATIONARY, versus axial fluting where it was ROTATING while current passed. How to collect: Establish whether the suspected current event (welding, drive fault) coincided with rotation or standstill.  
[#02 Burns from Electric Current, p.21, figs. 60 and 62]

- Presence of a variable-speed drive, recent welding on the machine, or degraded earthing/grounding connections. #01's case study is the caution worth carrying - an insulated bearing on a frequency-converter motor still failed by current leakage after a repair left the earth cable disconnected, so fitted insulation is not itself the answer. How to collect: Electrical installation record - drive type, earthing brush and earth cable condition, insulated bearing fitted or not, welding history.  
[#01 §7 Case studies, Variable speed electric motor problem, pp.88-89] [#02 Burns from Electric Current, p.21] [#04 Electrical Erosion, p.9]

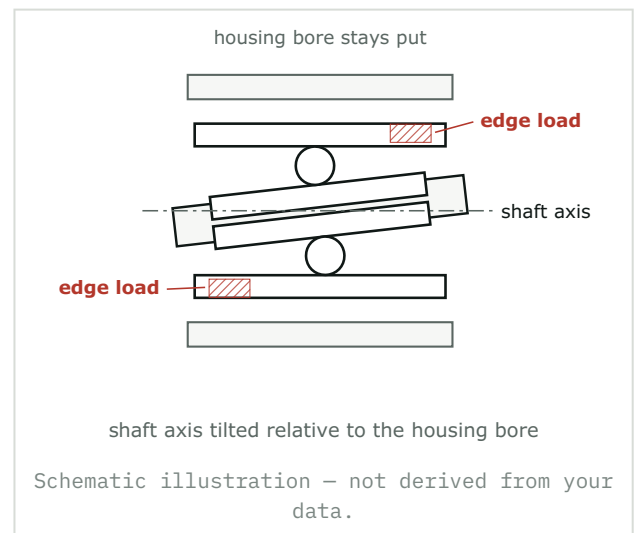
## 06 Shaft or seat misalignment concentrating load at the raceway edge

Misalignment tilts the rolling path so the load is carried on an edge instead of across the intended contact width, raising local stress well above design. Fatigue then appears on one side of the raceway only, or as two opposed load zones on a double-row bearing. [#01 §5 Damage and actions, Subsurface initiated fatigue, p.63, third caption] [#01 §5 Damage and actions, Surface initiated fatigue, p.65, bottom-left caption] [#02 Misalignment and Inaccurate Seat and Shoulder Machining, p.14] [#43 Table 4-5 Cause of Motor Bearing Failure, p.4-15 (PDF page 45)]

TWO COLLISIONS. (1) Both this and inner\_race\_excessive\_axial\_load can present as an axially offset load mark. Misalignment tilts the path; axial overload shifts it while keeping it square. Decide on the alignment record and the thrust arrangement, not on the mark alone. (2) Two load zones 180 degrees apart is shared with outer\_race\_oval\_clamping\_overload - #01 gives that signature

for an out-of-round seat at least as prominently. The discriminator is ring identity: a DOUBLE-ROW INNER ring points here, a stationary OUTER ring points to oval clamping.

- Spalling or a load mark confined to one side of the raceway width, rather than centred across it. How to collect: Dismounted inspection with the load-zone position recorded before cleaning. [01 §5 Damage and actions, Subsurface initiated fatigue, p.63, third caption] [02 Misalignment and Inaccurate Seat and Shoulder Machining, p.14]

- Two load zones 180 degrees apart on a DOUBLE-ROW bearing's inner ring. The ring identity is the discriminator - see the collision note. How to collect: Map both load zones and record which ring carries them before cleaning. [01 §5 Damage and actions, Surface initiated fatigue, p.65, bottom-left caption]

- Alignment record, shim history and soft-foot check for the machine train. How to collect: Last alignment report and any change of coupling, baseplate or foundation since. [01 §2 Inspection and troubleshooting, Table 2 solution codes 15 and 19-20, pp.19-21] [02 Misalignment and Inaccurate Seat and Shoulder Machining, p.14]

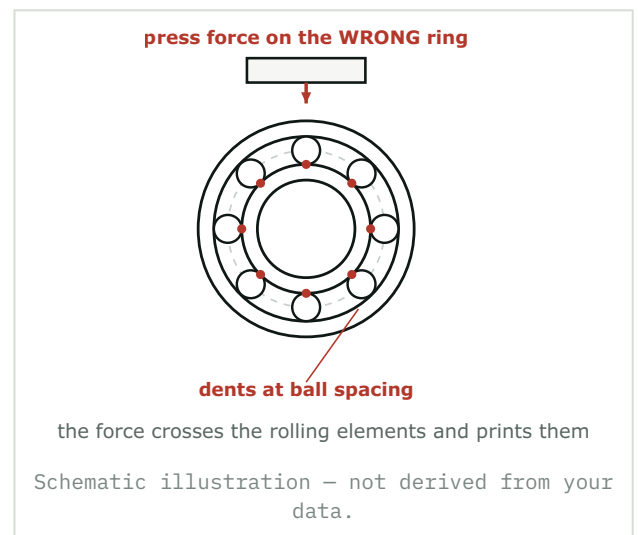
## 07 Impact during mounting, transmitted through the rolling elements

Driving a bearing onto a shaft by striking it forces the mounting load through the rolling elements instead of the ring being pressed, denting the raceway at each element position. The dents are permanent deformation rather than wear, and their raised edges later seed surface fatigue. [01 §5 Damage and actions, Surface initiated fatigue, p.65, bottom-right caption] [04 Plastic Deformation, p.10] [02 Handling and Installation Damage, p.15, figs. 41 and 42]

- Dents, or later spalls, spaced at exactly the rolling element pitch. How to collect: Measure the mark pitch and compare it with the rolling element pitch; equality is close to conclusive. [04 Plastic Deformation, Overload or true brinelling, p.10] [01 §5 Damage and actions, Surface initiated fatigue, p.65, bottom-right caption] [02 Handling and Installation Damage, p.15, fig. 42]

- STAGE-DEPENDENT SIGNATURE. Fresh dents early, spalls at element spacing later - #01's own exemplar for this cause sits under Surface initiated fatigue and shows spalls, not dents, so an inspection that finds no dents does not clear mounting impact. How to collect: Record whether the marks are unbroken depressions or broken-out spalls, and read that as stage rather than as a different cause.  
[#01 §5 Damage and actions, Surface initiated fatigue, p.65] [#04 Plastic Deformation, p.10]

- A raised lip or raised edges around the dent, which is what makes a mounting dent a future fatigue site rather than a cosmetic mark. How to collect: Inspect the dent rim under magnification, and record it separately from the dent itself.  
[#04 Plastic Deformation, p.10] [#02 Handling and Installation Damage, p.15, fig. 42]

- Roughness, vibration and noise reported immediately after an installation, rather than as a gradual change. How to collect: Compare the first post-maintenance vibration reading with the pre-removal baseline.  
[#02 Handling and Installation Damage, p.15]

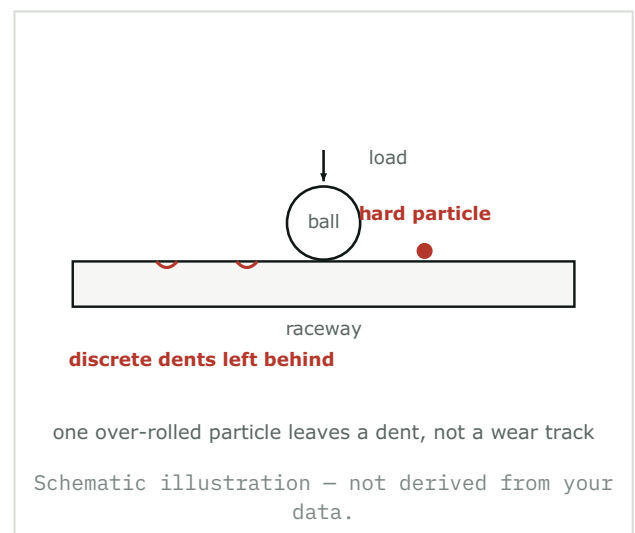
## 08 Hard debris over-rolled between element and raceway

A particle trapped in the contact is rolled over and pressed into the surface, leaving a round-bottomed dent with a raised rim rather than removing material. The rim concentrates stress on subsequent passes, so a contamination event becomes a fatigue initiation site. [#02 Wear - Pitting and Bruising, p.8] [#04 Plastic Deformation, Indentation from debris, p.10] [#01 §5 Damage and actions, Indentations from particles, pp.79-80]

- A BSF-matched carrier rather than BPFO or BPFI. Sidebands alone do NOT point to a rolling-element fault: the detector adds +/-1x shaft sidebands to every committed bearing family alike, so the specificity is in which fault frequency the carrier matches, not in the presence of modulation.  
[inferred]

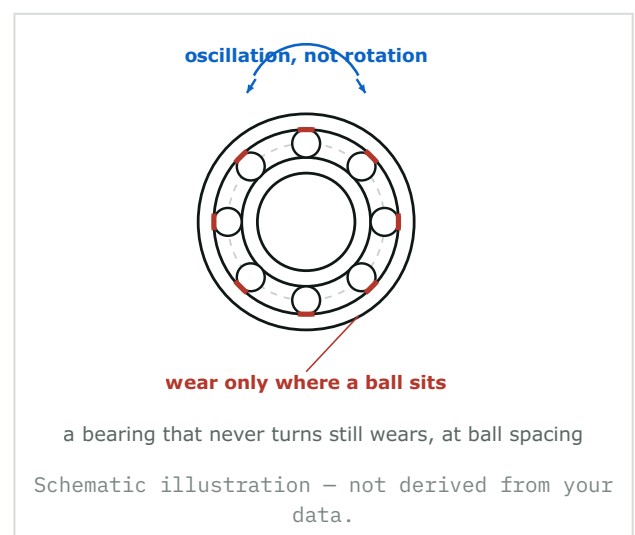
## 09 Vibration or oscillation while the bearing is stationary

A bearing that is not turning still carries its load on a few elements, and external vibration makes each element rub a few microns back and forth on the same spot. That repeated micro-movement wears the surface away where a static load alone would have left it untouched. [#01 §4 ISO failure modes classification, Frictional corrosion - False brinelling, p.52] [#01 §5 Damage and actions, False brinelling, p.73] [#01 §2 Inspection and troubleshooting, Table 2 condition 36, p.26]

- Marks at the rolling element spacing, in the loaded zone, worn TRANSVERSELY across the race width by slight AXIAL movement of the element rather than merely sitting on one spot. How to collect: Measure the mark pitch against the rolling element pitch, and record the mark's orientation across the race width.

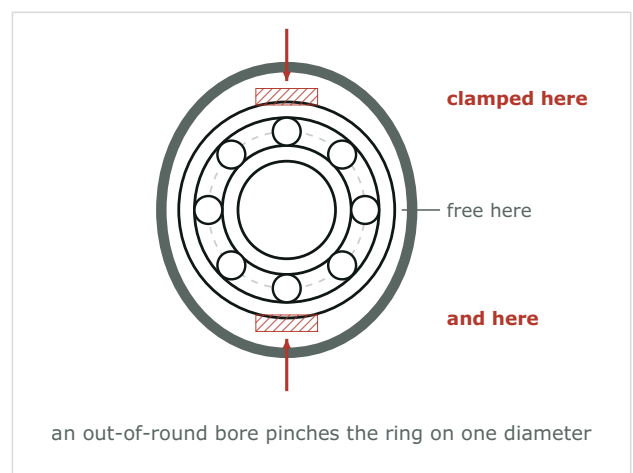
## 10 Housing distortion clamping the outer ring oval

A housing bored or bolted out of round squeezes the outer ring into an oval, creating two diametrically opposed high-load regions where the design intended one. Fatigue then appears as spalling roughly 180 degrees apart rather than in a single load arc. [#01 §3 Path patterns, Inner ring rotation - oval clamping of the stationary outer ring, p.37] [#01 §2 Inspection and troubleshooting, Table 2 solution code 15, p.19]

RING IDENTITY. Two opposed load zones 180 degrees apart is NOT specific to oval clamping - #01 gives the same signature for excessive misalignment on a double-row bearing. The discriminator visible in the source is which ring carries it: the OUTER ring points here, a double-row INNER ring points to inner\_race\_misalignment\_edge\_loading.

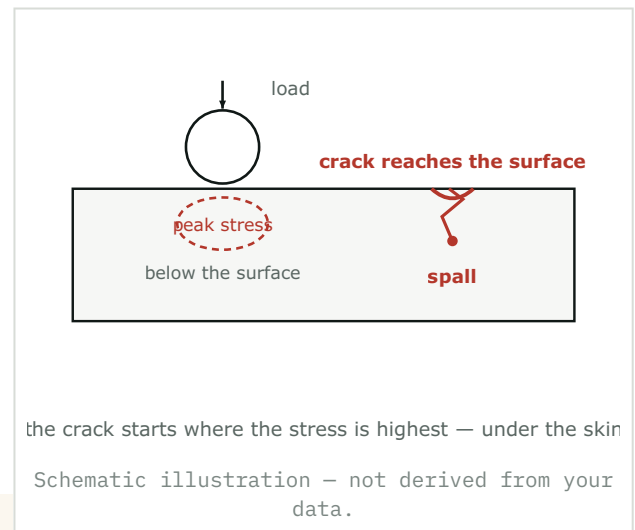
Repeated stress cycles nucleate cracks at inclusions below the contact surface, and those cracks grow until a piece of the surface detaches. This is the mechanism the bearing rating life describes, so it is the one cause on this list that is not a defect in installation or operation. [#01 §5

LAST. Weigh every other cause in this batch before this one. It is the only entry that concludes nothing was done wrong, so reaching it early ends the investigation that the other thirteen entries exist to run. #04 p.3 puts a number on the prior: subsurface fatigue is not a common issue where better quality metals are used, and most bearings will fail by another mechanism first.
